**Sonar Dome Reliability XVIII: Measured
Deflections of the USS Kauffman Sonar
Rubber Dome, 15-25 Nov 1992**

13. ABSTRACT (Maximum 200 words) Deflection measurements were performed on the Sonar Rubber Dome (SRD) of the USS Kauffman using an acoustic time-in-flight system. This report documents modifications of the previous deflection measurement system, field tests of the experimental equipment, the installation process, initial shakedown cruise, and describes the data collected during the at-sea voyage of 15-25 Nov 1992. We obtained comprehensive deflection data on 65 locations of the SRD as well as extensive environmental data. The environmental data included ship speed and course, dome pressure and temperature, roll, pitch, sound speed and salinity inside the SRD, and 3D acceleration. The deflection measurement system suffered a performance degradation after installation, and possible causes are discussed.

**SONAR DOME RELIABILITY XVIII:
MEASURED DEFLECTIONS OF THE USS KAUFFMAN
SONAR RUBBER DOME, 15-25 NOV. 1992.**

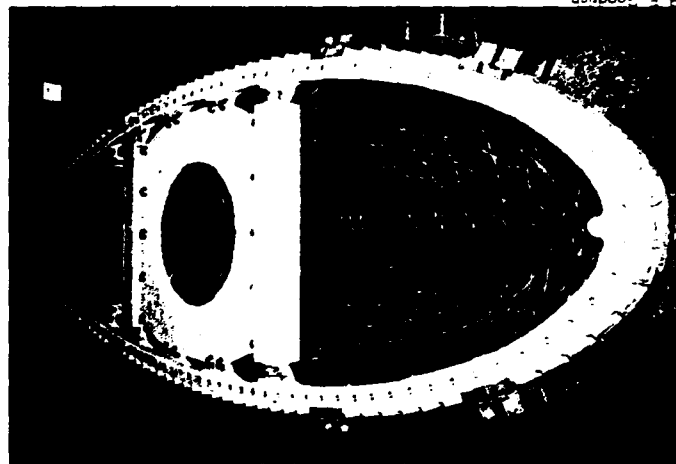
Figure 3: SDADMS Driver Transducer Locations

The set up at NRL/CBD

Junction Box, Star Modules and Floating Receiver Array

Completed installation at BFG

Coordinate grid and hydrophones in forward end

From August 1991 to January 1992 a prototype SRD Deflection Measurement (SRDDM) system was installed on an old SRD at the Chesapeake Bay Detachment (CBD) of NRL. This dome was mounted in a shipping fixture, sandbagged underneath for additional support, and water filled to allow for acoustic tests on hydrophone placement, directivity, and overall system checkout. The top two pictures in Figure 3 show the dome used at CBD with the test system installed. The electronic and computer equipment was housed in a portable trailer shown in the background.

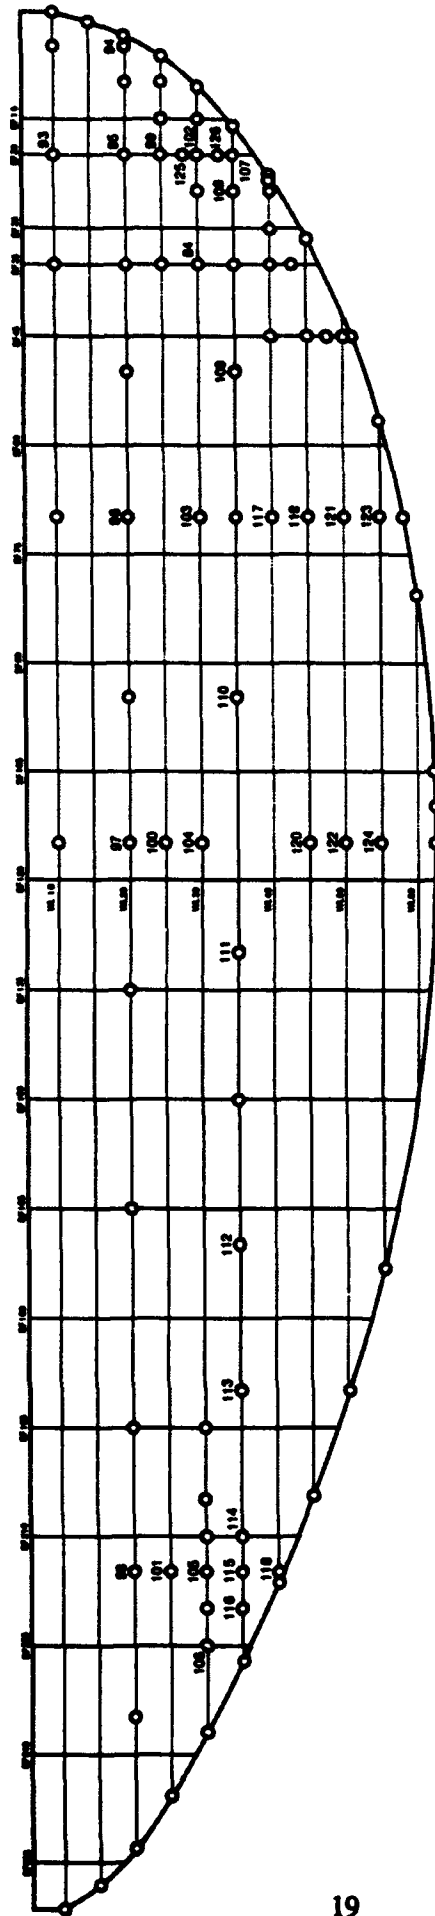
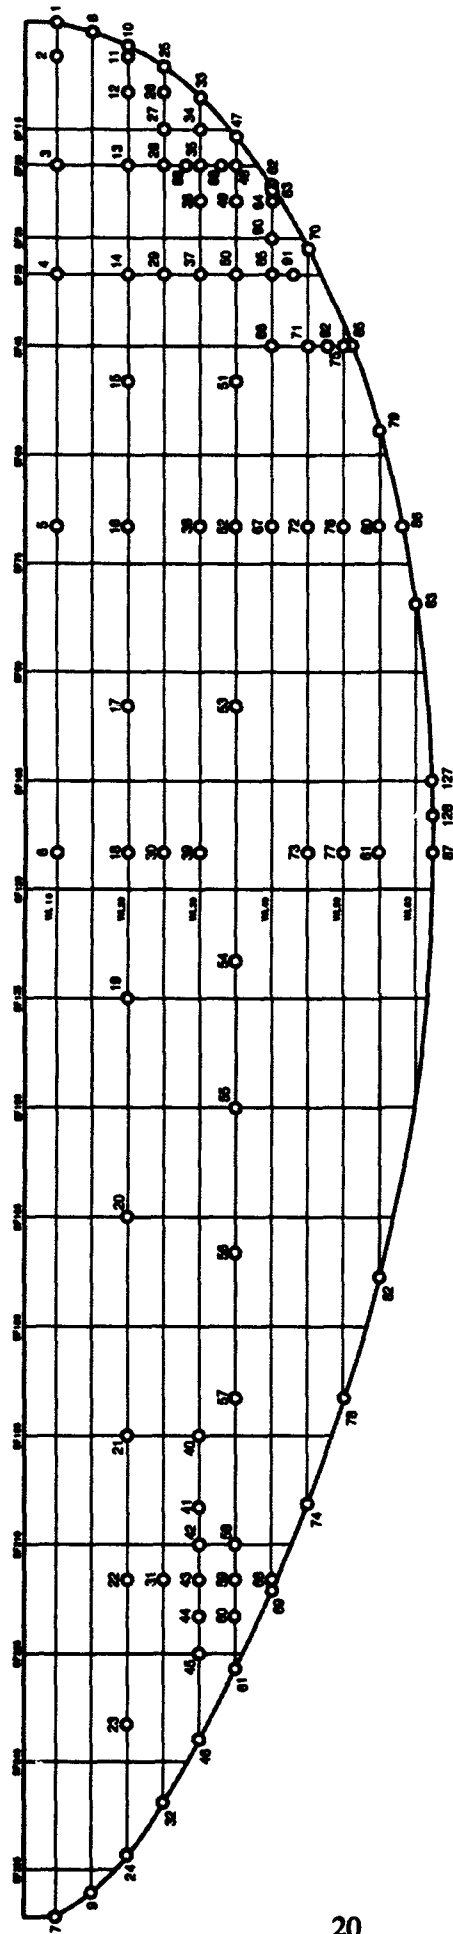
Figure 4: NRL Computer Model of SRD for Investigation of Deflection Sensor Locations

Port Side

Transducers 93-126

Starboard Side
Transducers 1-92, 127 and 128

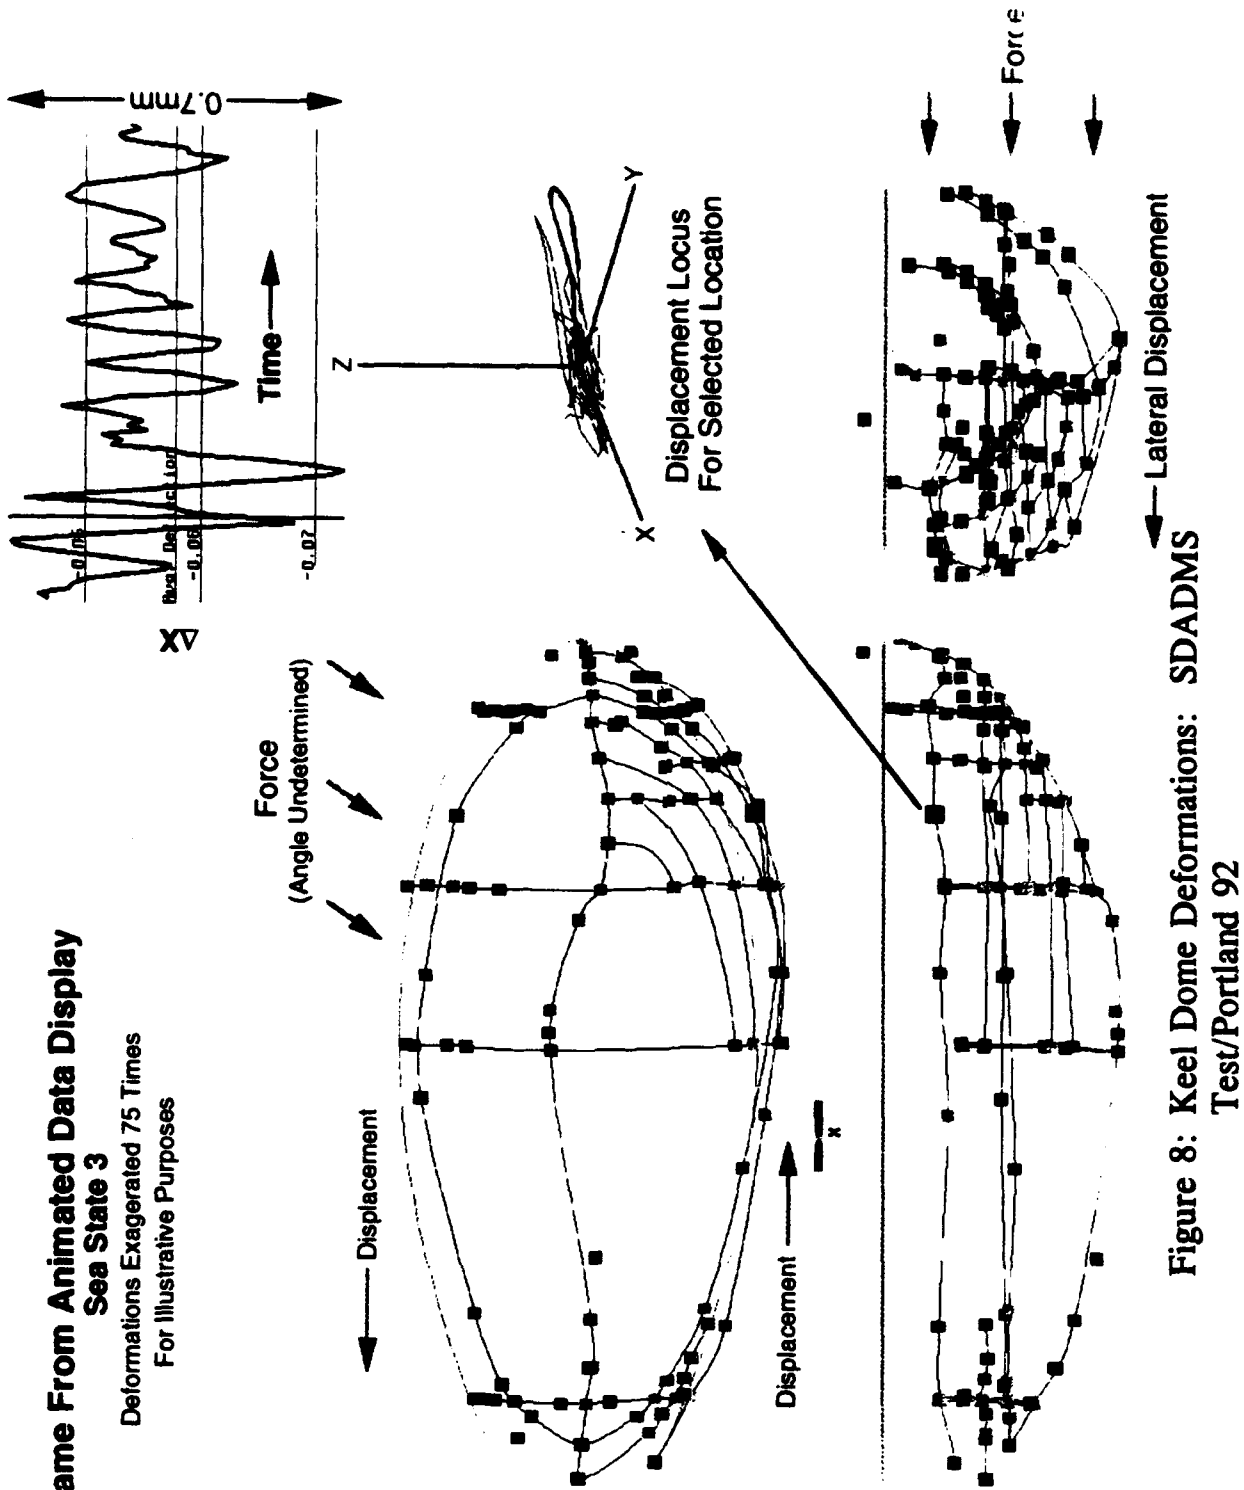
Figure 8: Keel Dome Deformations: SDADMS
Test/Portland 92

Frame From Animated Data Display

Sea State 3

Deformations Exaggerated 75 Times
For Illustrative Purposes

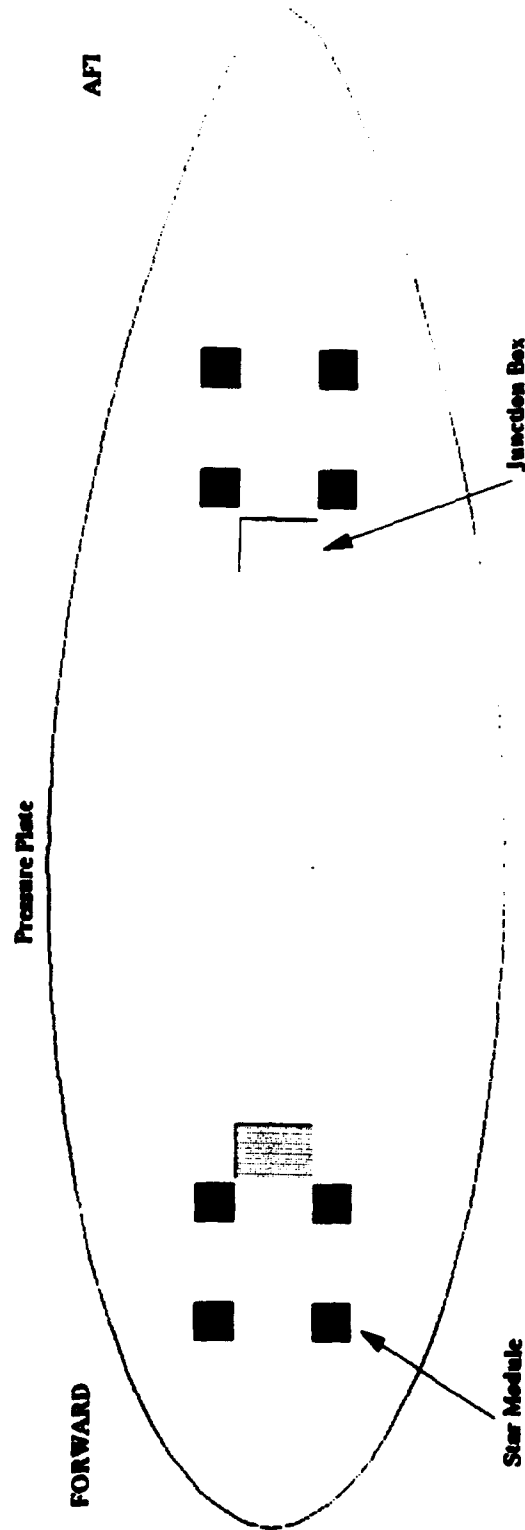
Appendix (2): Pressure Plate Weld Locations

WELD LOCATIONS: Two support brackets (or bars) will be welded onto the pressure plate for each star module and junction box, for a total of 20 welds. One bar forward and one aft for each unit to be installed. Approximate locations are shown above. Exact weld locations will be provided by NRL personnel during drydock installation.

- (1) Install support brackets described in Appendix (3) (4 type (a) and 16 type (b)) and weld to pressure plate.
- (2) Perform the installation of the new cable-way.
- (3) Install new stuffing tubes.
- (4) Install support structure for wave height sensor on bow, and route associated cable to sonar equipment room through stuffing tubes to allow for watertight conditions.
- (5) Assist in the modified installation procedure for the SRD.

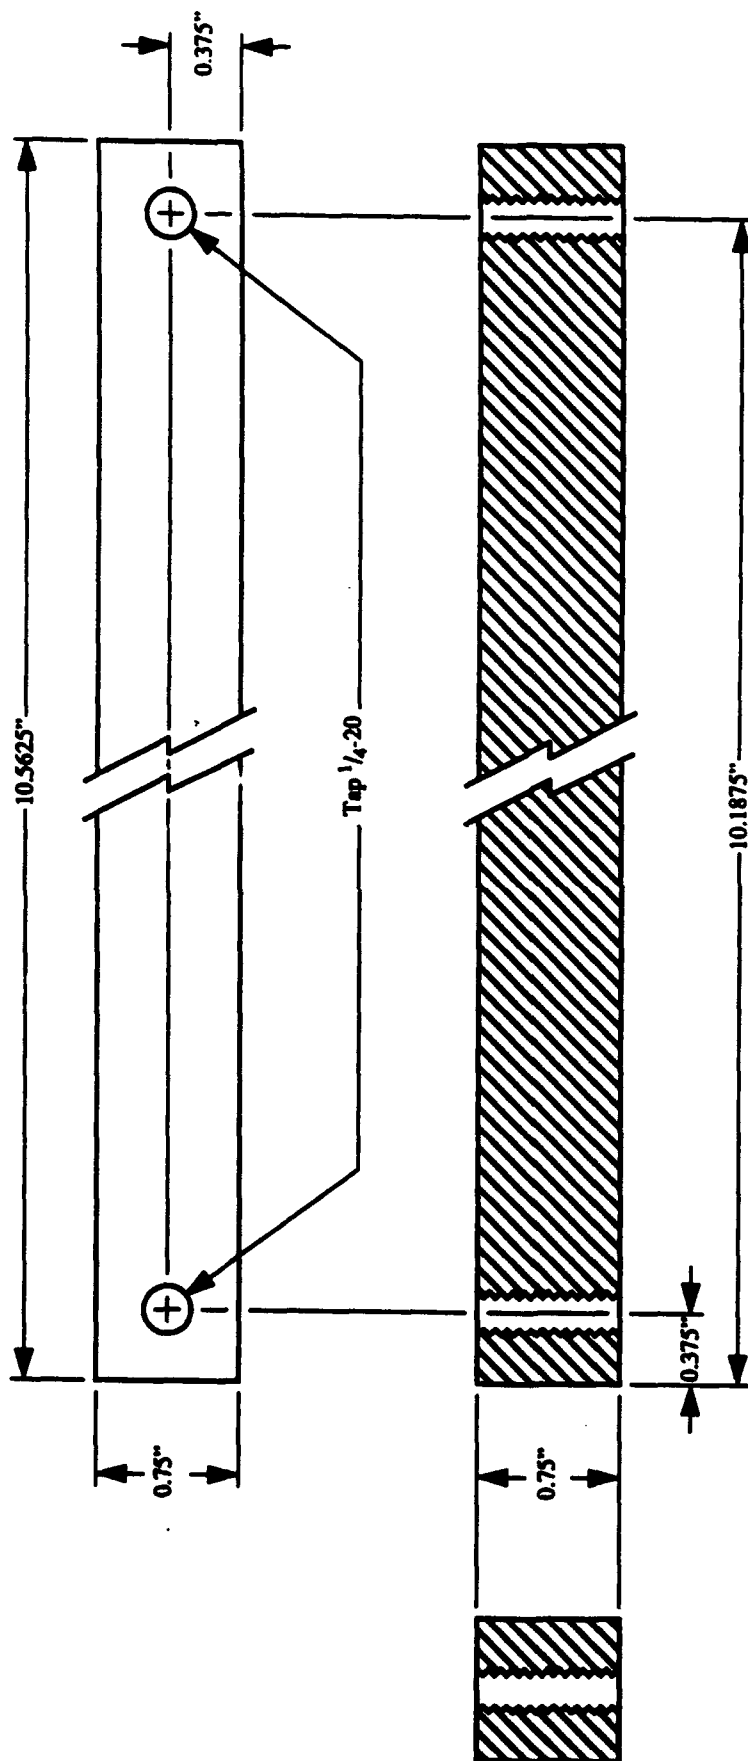
Appendix (3a): Junction Box Mounting Bar

Notes: The material used is Carbon Steel Square Stock; 4 pieces were made.

The Shipyard must arc weld these to the SRD Pressure Plate at locations specified by an on-site NRL representative.

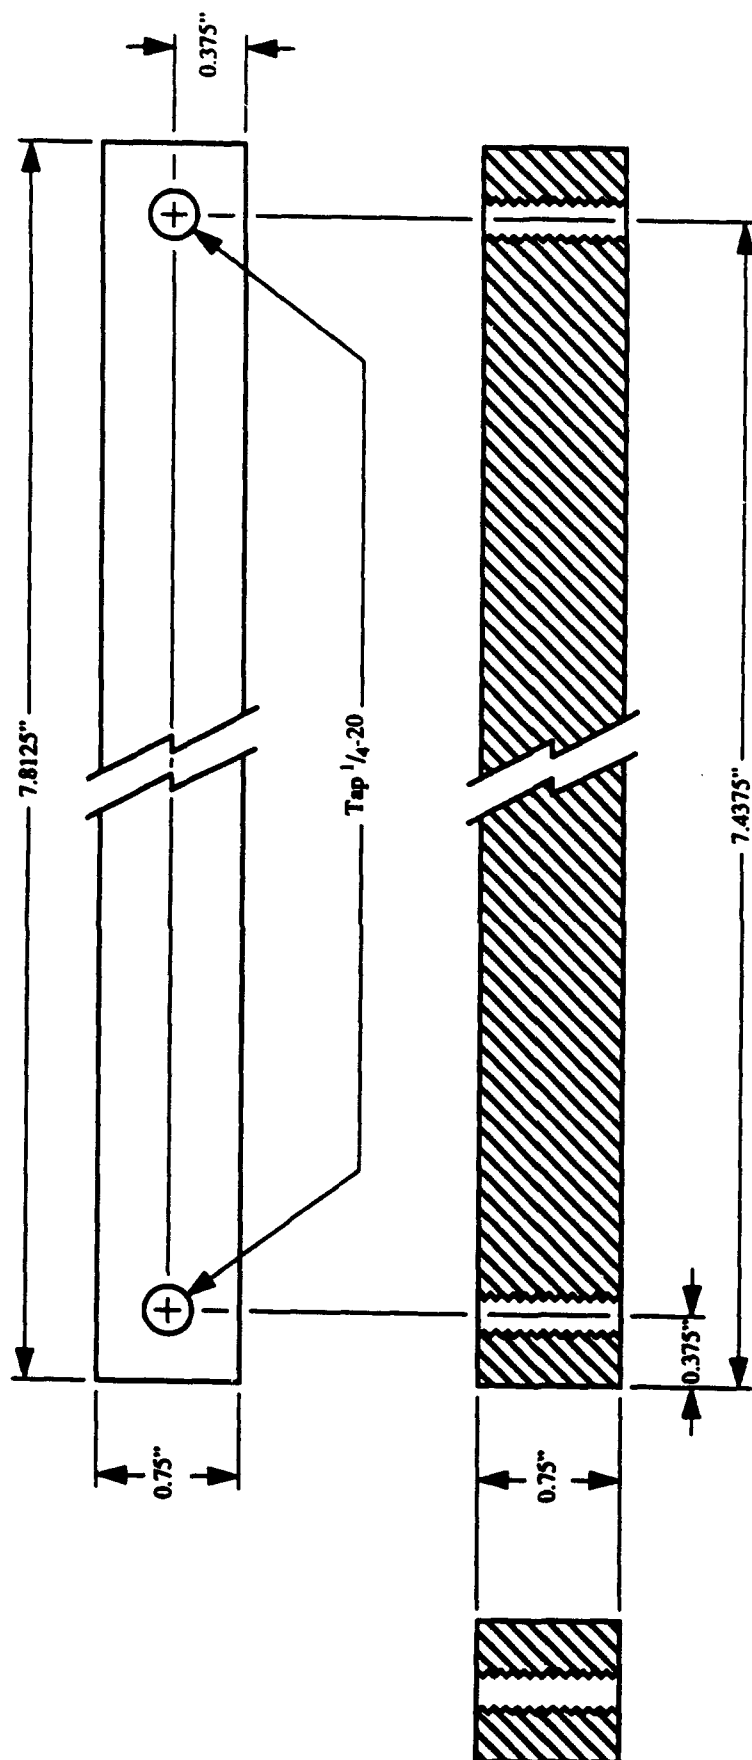
Appendix (3b): Star Module Mounting Bar

Notes: The material used is Carbon Steel Square Stock; 16 pieces were made.
The Shipyard must arc weld these to the SRD Pressure Plate at locations specified by an on-site NRL representative.
